# Manhole Inspection Summary

Manhole # S15AA\_034MH

Insp Date: **11/15/07 12:21 PM**

**Location** Address: **801 BRADDISH AVE** Cross Street: **W LAFAYETTE ST**

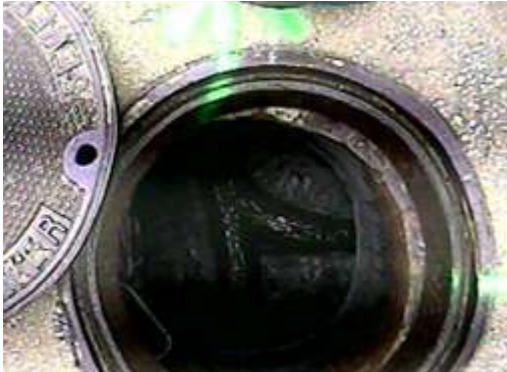
Top View

**Frame** Offset: **2** (in.) Condition: ☒ Sound ☐ Cracked ☐ Leaks

FRAME OFFSET

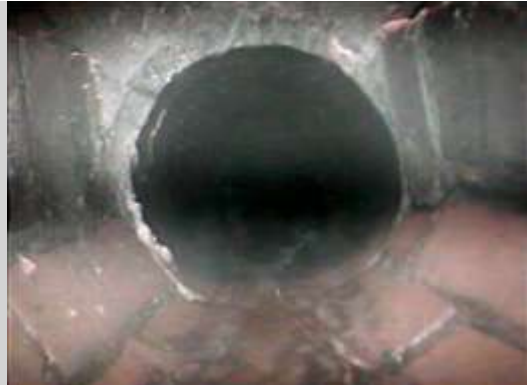
12 O'Clock Outflow

8 in. Circular Gravity Sewer  
Pipe Out @ 12 O'Clock

Pipe Material: **Clay** ☐ Pipe Lined

Invert Depth: **8.20** (ft.) Flow Characteristics: **Slow**

Infiltration: **None** Pipe Seal Cond: **Sound**

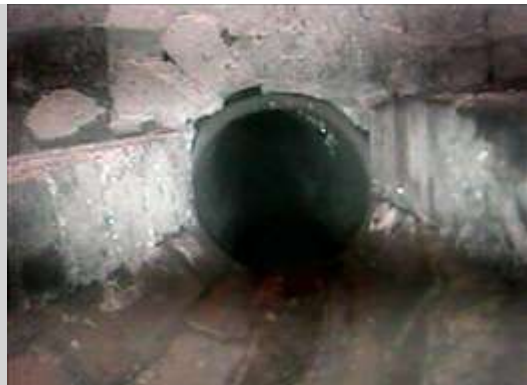
3 O'Clock Inflow

8 in. Circular Gravity Sewer  
Pipe In @ 3 O'Clock

Pipe Material: **Clay** ☐ Pipe Lined

Invert Depth: **8.12** (ft.) Flow Characteristics: **Slow**

Infiltration: **None** Pipe Seal Cond: **Sound**

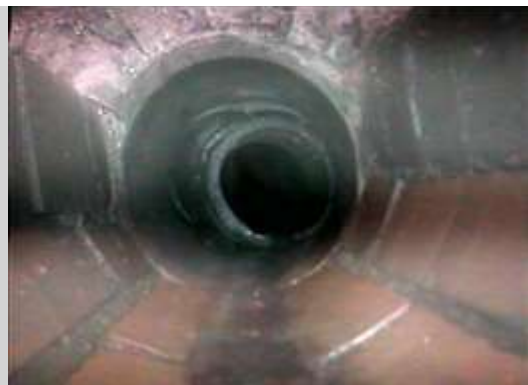
6 O'Clock Inflow

8 in. Circular Gravity Sewer  
Pipe In @ 6 O'Clock

Pipe Material: **Clay** ☐ Pipe Lined

Invert Depth: **8.10** (ft.) Flow Characteristics: **Slow**

Infiltration: **None**

Pipe Seal Cond: **Sound**
